Learning from Experience: Completing a Subsea Dual ESP Well, second time round.

Solan Field, West of Shetland

Stewart McIntosh – Artificial Lift Solutions

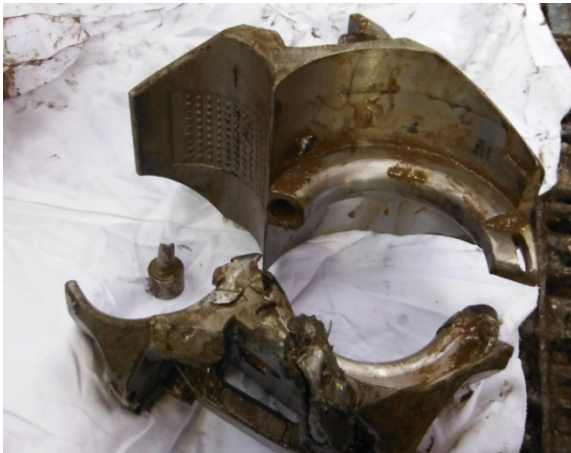
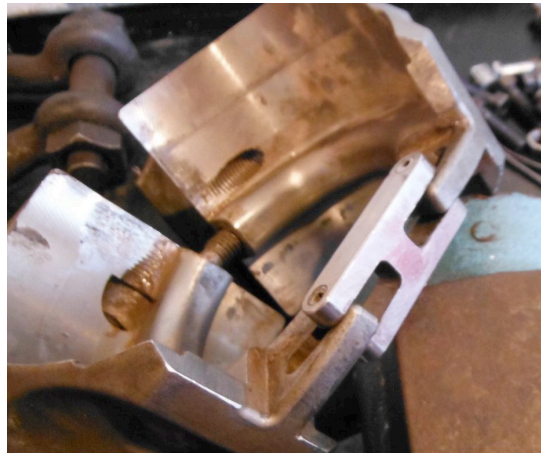
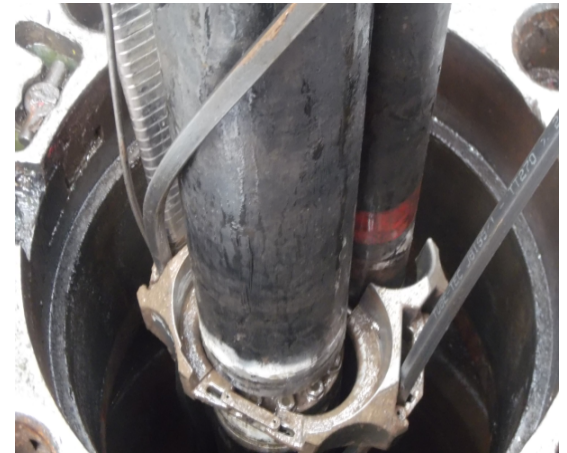
- The ESP wouldn't pass through the GE HXT (Helix)
 - 11 days spent trying
 - Testing Y-Tool on drill pipe, it rotated 60° through the Helix
- Detaching Pump Support Block Spear
- ESP Bypass Clamps failed
 - Clamp sheared and was riding against Y-Tool

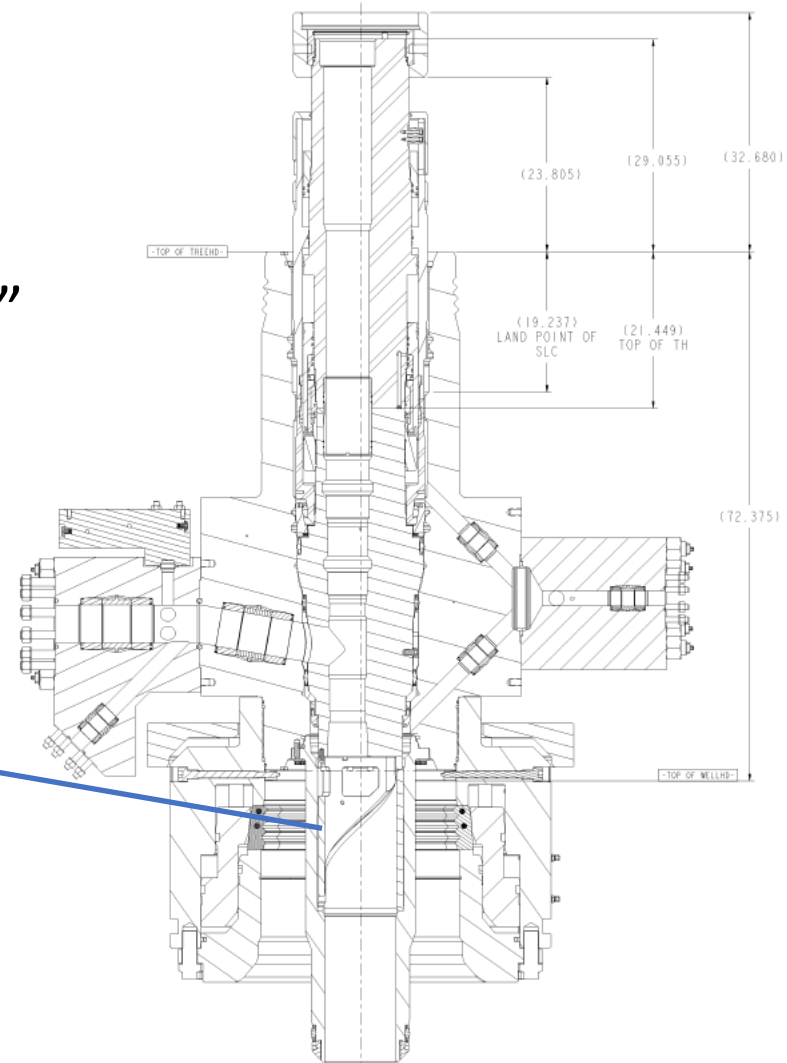
Helix profile
Tubing Hanger
orientation
9.760" ID with a
casing ID of 9.66"

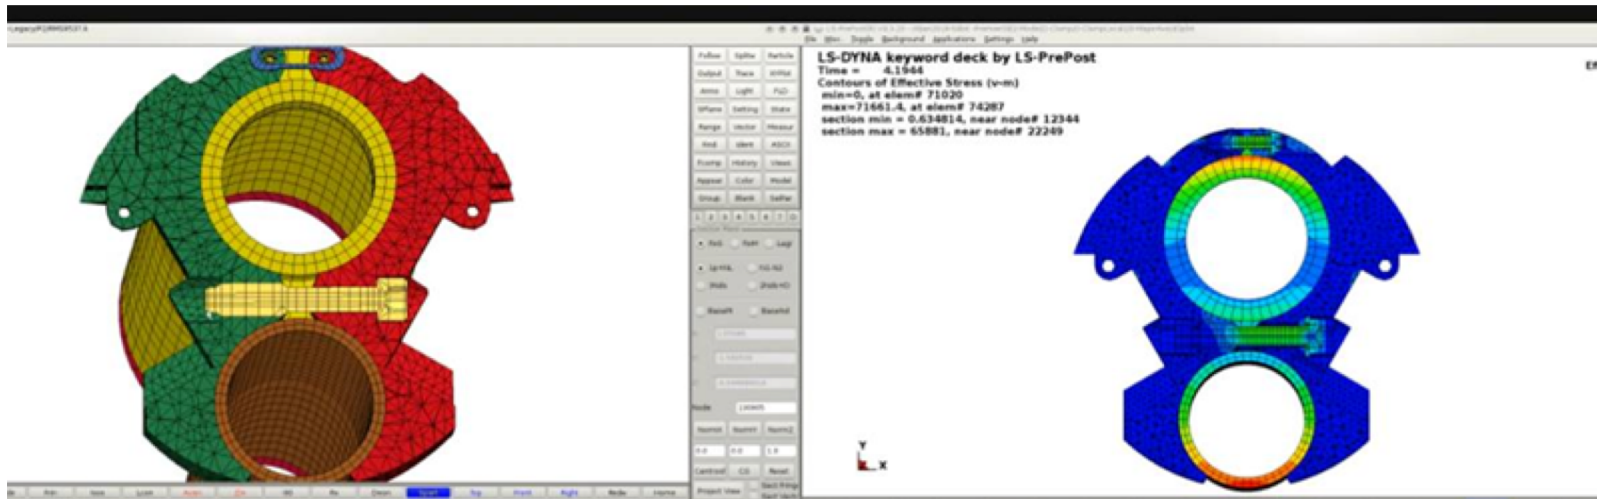
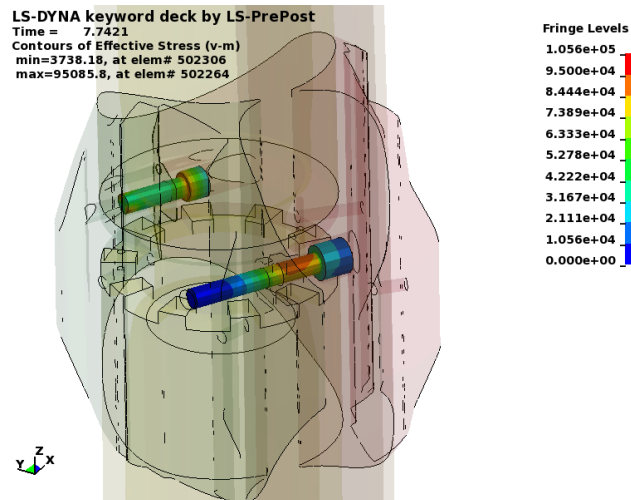
- The Bypass Clamp redesign was a high priority due to issues faced previously
- RMSpumptools created a new design
- Robust two bolt clamp was created – no hinge.
- Reduced OD (9.563” to 9.504”)
- Nord-Lock Washers
- Ran Qualification testing
 - Shock Loading
 - Vibration Testing

- Engenya Design Analysis was run

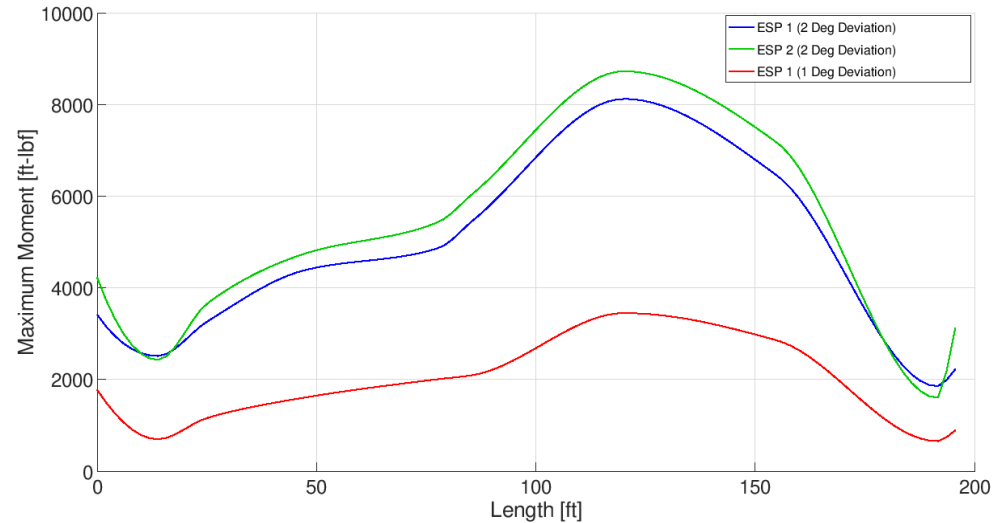
- Maximum Moment v ESP Length

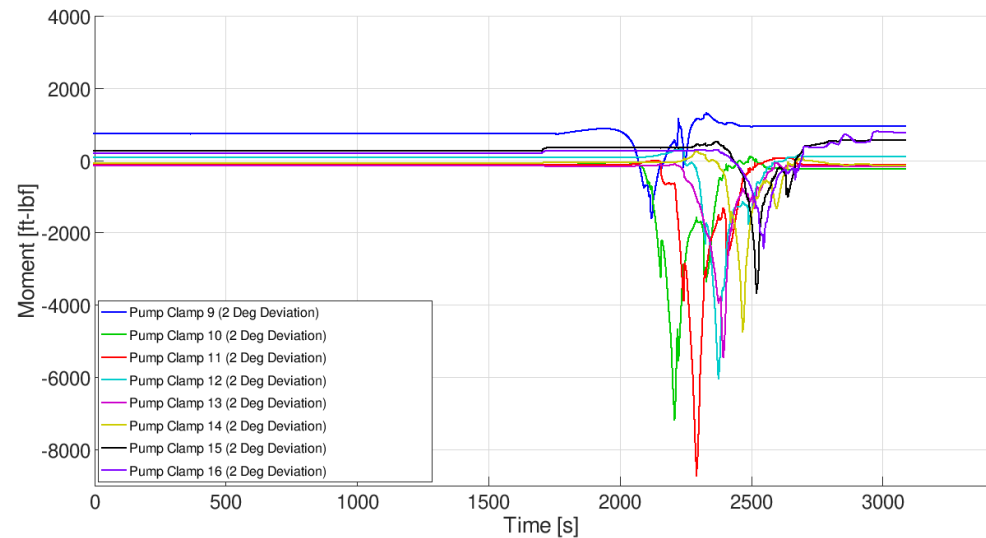
- Moment on ESP Clamps

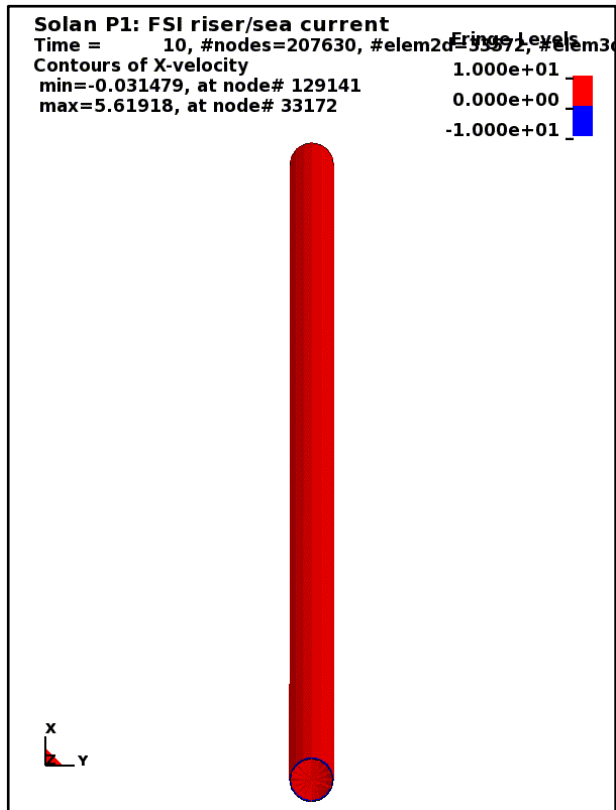
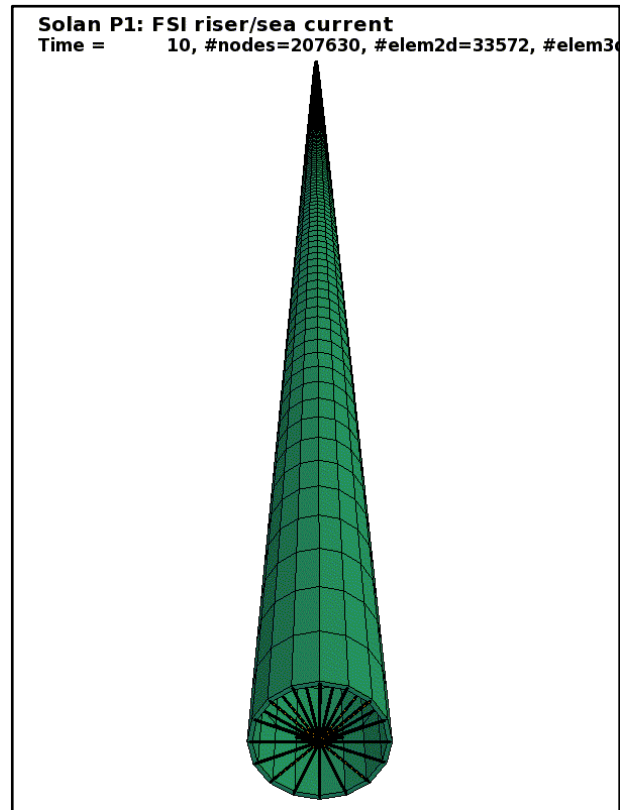
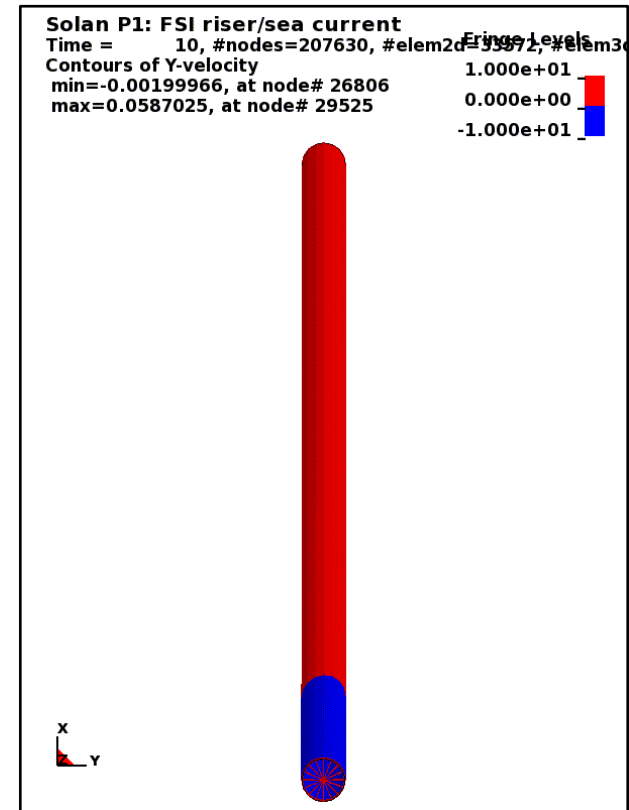
- Other / Vessel or Riser Movement / Vortex induced Vibration?

- Deflection force decreased to an 1/8 of previous levels

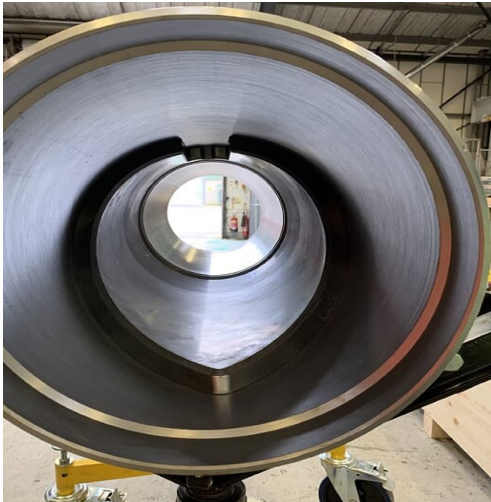
Helix back from
Manufacturing

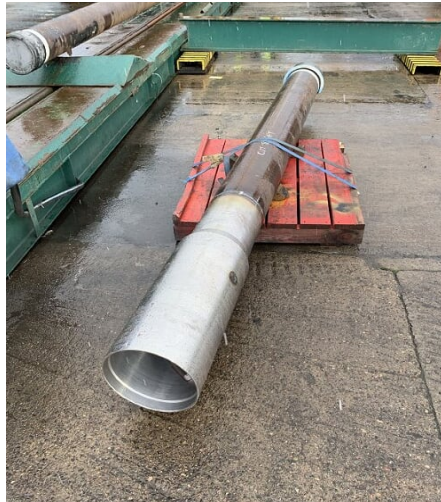
Helix with 10-3/4"
pup welded on

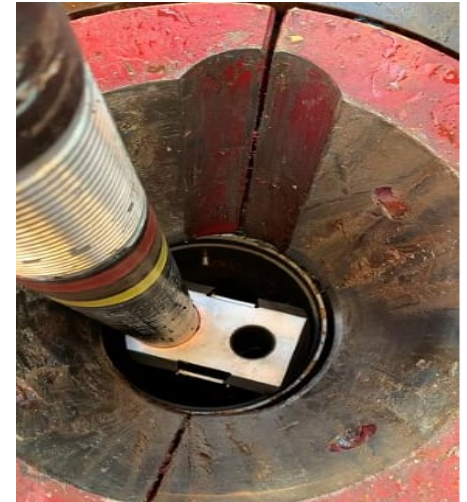
Helix in action with
pump support block

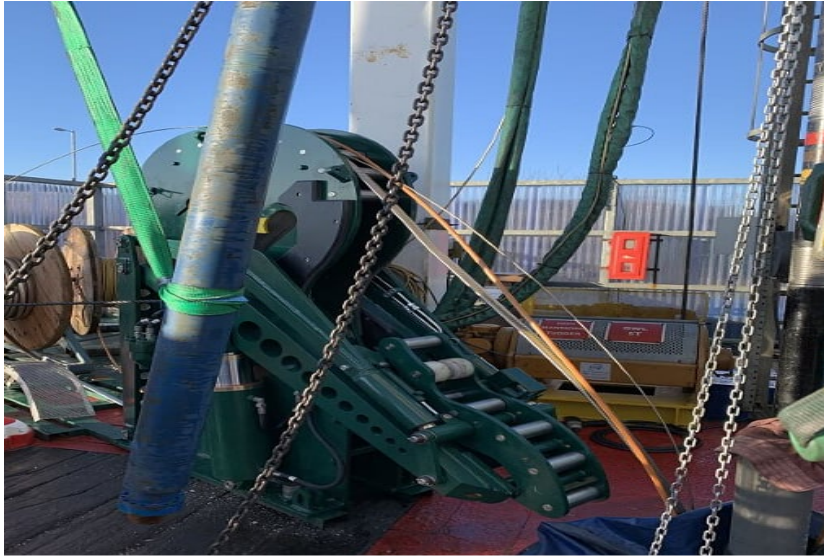
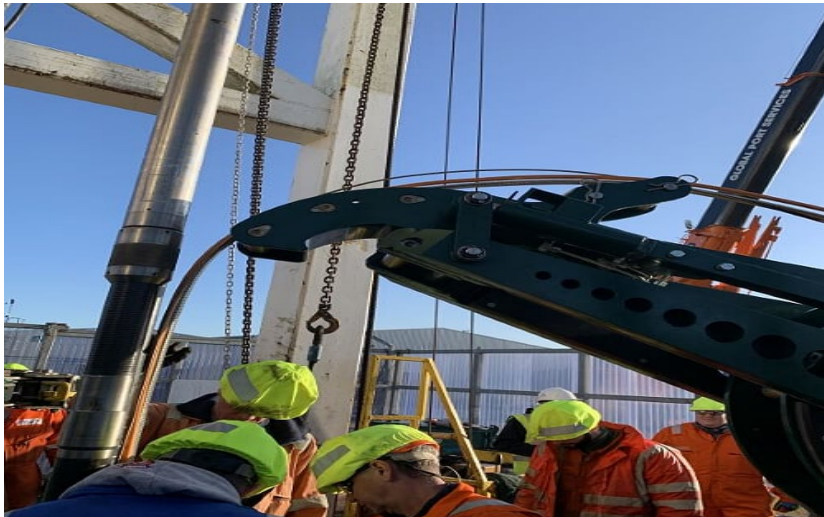
- SCLMA had 3 lines
- Worked great with back tension spoolers
- Lifts lines out the way for installing clamps
- Shear guillotine with remote
- Reduces manual handling of the MLE's

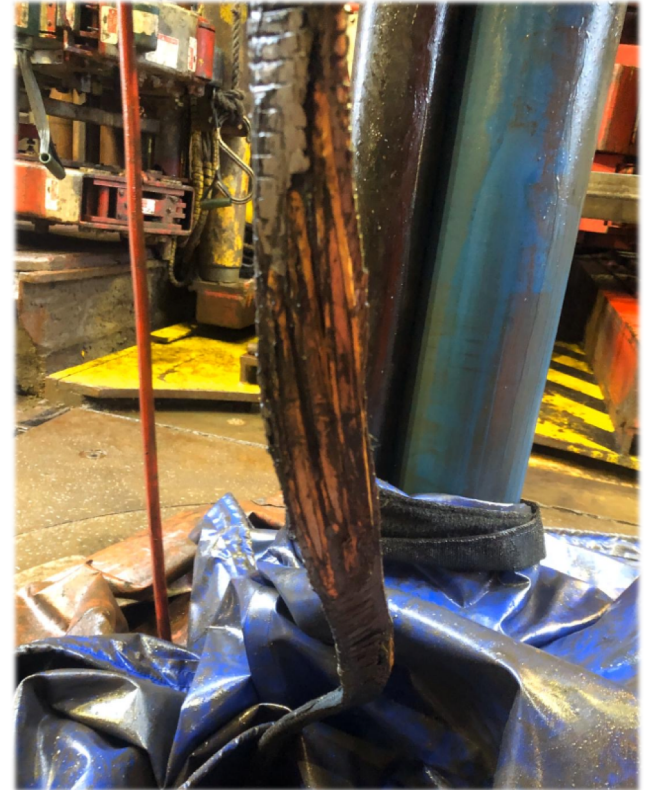
- There were some issues encountered...
 - Incident when a BPT joint was damaged, the ESP hung up at surface
 - Lost readings through the subsea umbilical. when the ESP was landed
 - Electrical readings were unable to be taken when landing
 - The MLE was destroyed by abrasion

- More provisions for electrical testing through Subsea umbilical had to be made to ensure integrity when landing
 - We ironed out a lot of this on Run 2
- Communication must be maintained at ALL times – this was the root cause of the BPT incident
- Base all MLE marking on actual measured lengths. Keep markings to a sensible minimum
- Bypass Tubing Lengths should be determined after the ESP design is finalised. Handling and ‘stick up’ should be planned
