Learning from Experience: Completing a Subsea Dual ESP Well, second time round.

Solan Field, West of Shetland

Stewart McIntosh – Artificial Lift Solutions

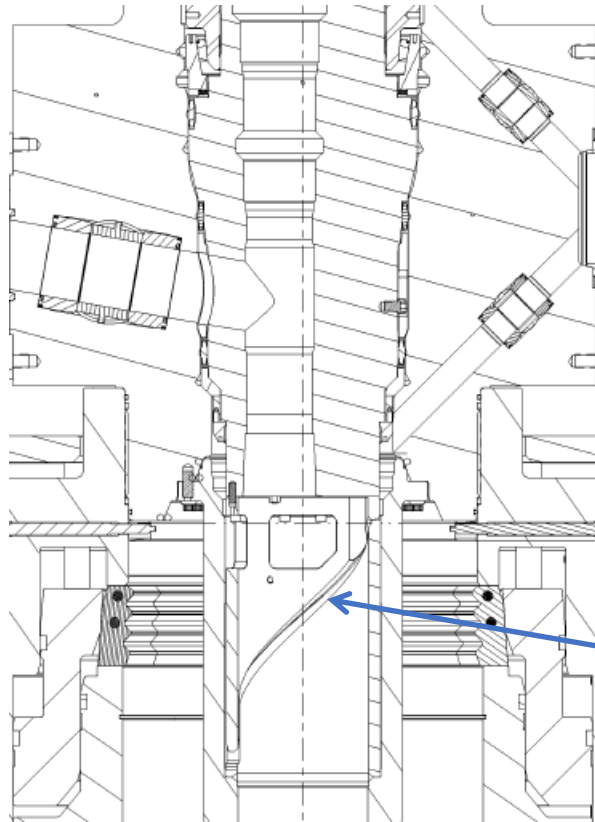
- The ESP wouldn't pass through the GE HXT (Helix)
 - 11 days spent trying
 - Testing Y-Tool on drill pipe, it rotated 60° through the Helix
- Detaching Pump Support Block Spear
- ESP Bypass Clamps failed
 - Clamp sheared and was riding against Y-Tool

Helix profile
Tubing Hanger
orientation
9.760" ID with a
casing ID of 9.66"
